# 2022 PAVEMENT MANAGEMENT REPORT

Dundas, MN

PREPARED FOR: CITY OF DUNDAS  
100 RAILWAY STREET NORTH  
DUNDAS, MN 55019

WSB PROJECT NUMBER: 019661-000

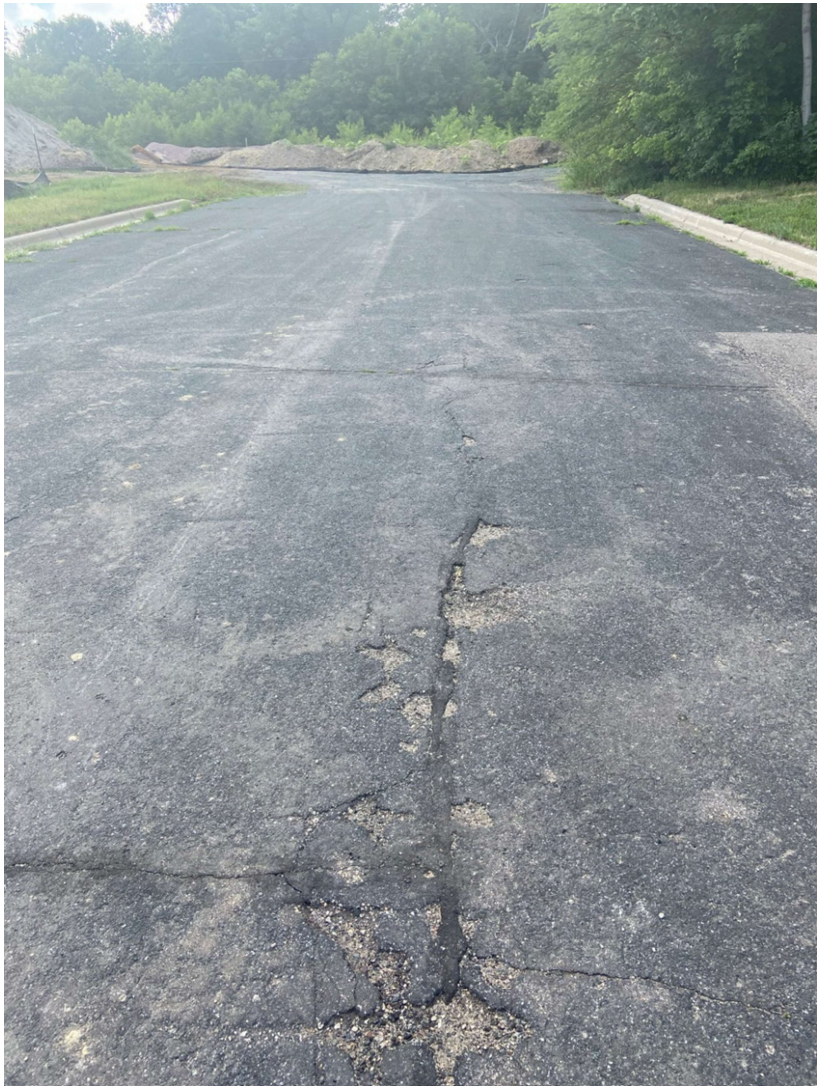
#### ***Bridge St (Segment ID: 35)***

### **PCI Rating = 40: Failed**

When a road's PCI rating is 40 or below, the pavement shows high severity distresses at multiple locations or extensive moderate and low severity distresses. The street has deteriorated to the point where the structural integrity has diminished along with the driving surface. Drivers using segments of this condition experience bumpy and rough rides. Typically, streets of this category require reconstruction. Reconstruction involves removing the pavement at full depth, through the surface layers of asphalt and into the gravel base, and constructing the street to its original state. Reconstruction is very costly, so every effort should be made to keep streets from entering this category.

- Alligator Cracking, Moderate Severity, 1.83%
- Block Cracking, Low Severity, 0.89%
- Edge Cracking, Low Severity, 0.83%
- Edge Cracking, Moderate Severity, 1.54%
- Edge Cracking, High Severity, 0.35%
- Longitudinal/Transverse Cracking, Low Severity, 5.41%
- Longitudinal/Transverse Cracking, Moderate Severity, 2.92%
- Patching, Low Severity, 15.75%
- Potholes, Low Severity, 0.08%
- Weathering, Moderate Severity, 100%

| Branch ID | Section ID | Length (ft) | Area (ft <sup>2</sup> ) | 2022 PCI | Recommended Maintenance |
|---|---|---|---|---|---|
| BRIDGE ST | 35 | 328 | 9,192 | 40 | Reconstruction |

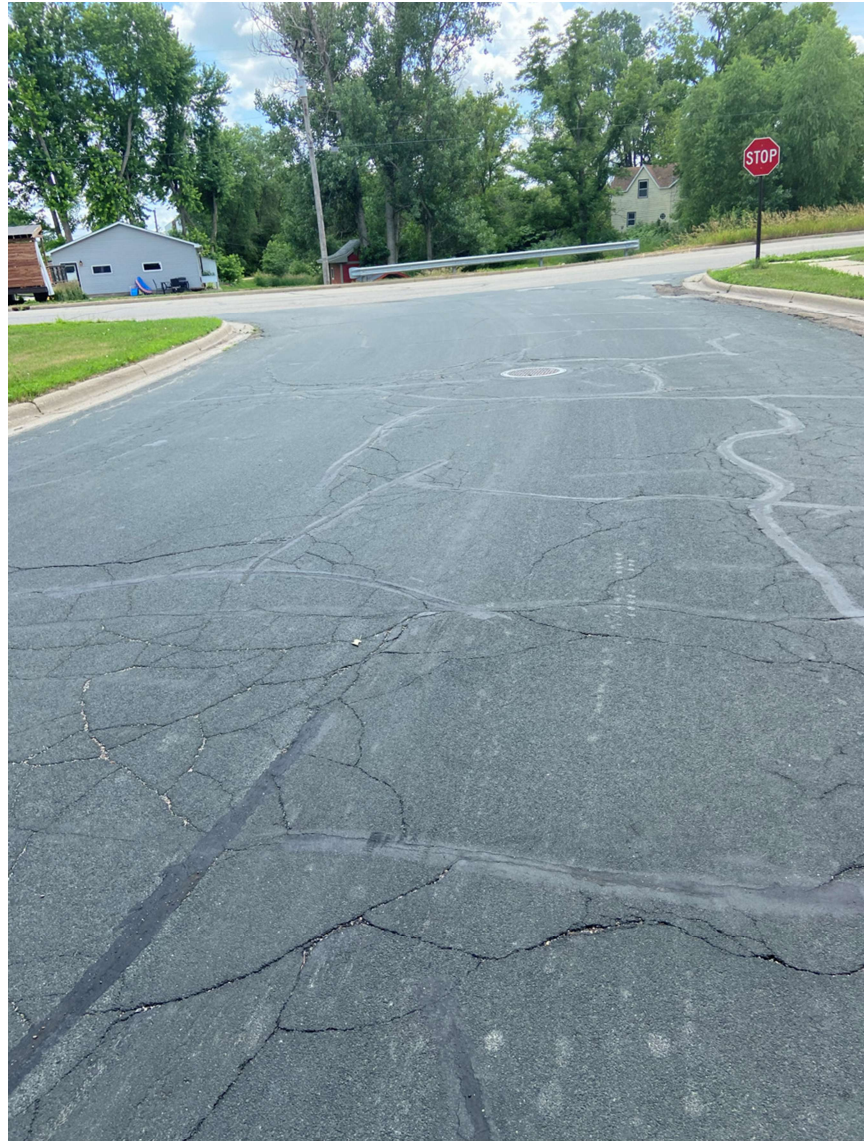
**PCI Rating = 48: Poor*****Forest Ave (Segment ID: 38)***

Roads in the Poor category are at the point where the number and severity of distresses dramatically worsen. Moderate and high severity distresses become common. Drivers experience many bumps while using these streets. Maintenance tactics such as crack sealing and seal coating are not effective, as the pavement has deteriorated beyond the point of repair. If the damage has not yet reached the base of the road, reclamation is recommended. Reclamation is an in-place recycling method for reconstruction of flexible pavements using the existing pavement section material as the base for a new roadway-wearing surface. While reclamation projects are much cheaper than reconstructions, it is still a costly procedure.

- Alligator Cracking, Low Severity, 0.81%
- Alligator Cracking, Moderate Severity, 1.27%
- Block Cracking, Moderate Severity, 0.42%
- Edge Cracking, Moderate Severity, 0.63%
- Longitudinal/Transverse Cracking, Low Severity, 1.06%
- Longitudinal/Transverse Cracking, Moderate Severity, 1.09%
- Potholes, Low Severity, 0.05%
- Potholes, High Severity, 0.02%
- Weathering, Moderate Severity, 100.00%

| Branch ID | Section ID | Length (ft) | Area (ft <sup>2</sup> ) | 2022 PCI | Recommended Maintenance |
|---|---|---|---|---|---|
| FOREST AVE | 38 | 361 | 10,110 | 48 | Reclamation |

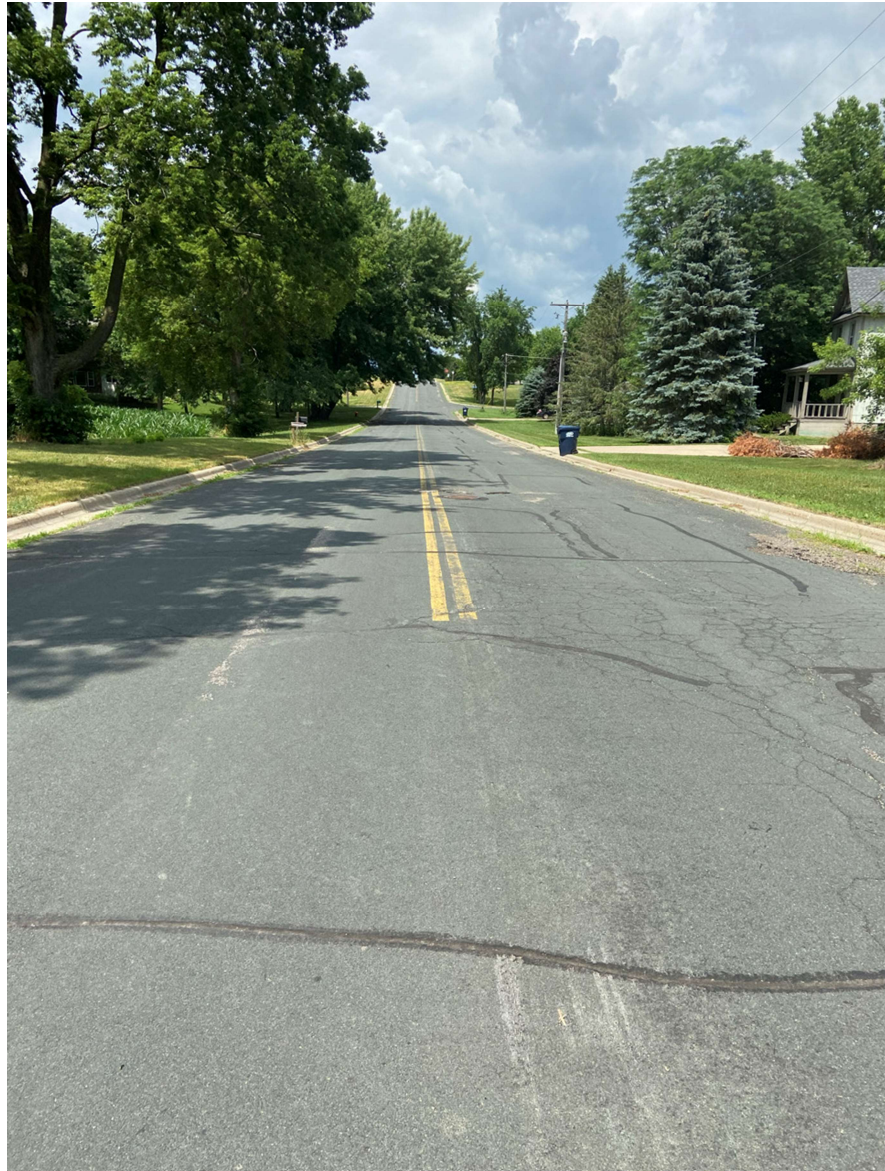
**PCI Rating = 69: Fair*****Depot St N (Segment ID: 30)***

Segments rated as Fair may have a few moderate and severe distresses but usually only have mild widespread distresses. The road shows wear but it is still structurally sound. Drivers may experience some bumps while using these segments, but the driving surface is mostly smooth. Typically, streets in this category can be rehabilitated with a mill and overlay. This method involves milling off the top part of the pavement and replacing it with a new lift of fresh asphalt. Milling eliminates most of the distresses since they are usually mild and still only on the surface. The overlay provides a new driving surface while utilizing the existing base which is still in adequate condition. This strategy prevents the pavement from deteriorating past the point where repairing it is no longer cost-effective.

- Alligator Cracking, Moderate Severity, 0.79%
- Edge Cracking, Low Severity, 0.81%
- Edge Cracking, Moderate Severity, 0.18%
- Longitudinal/Transverse Cracking, Low Severity, 1.79%
- Longitudinal/Transverse Cracking, Moderate Severity, 0.94%
- Weathering, Moderate Severity, 100.00%

| Branch ID | Section ID | Length (ft) | Area (ft <sup>2</sup> ) | 2022 PCI | Recommended Maintenance |
|---|---|---|---|---|---|
| DEPOT ST N | 30 | 462 | 12,936 | 69 | Mill/Overlay |

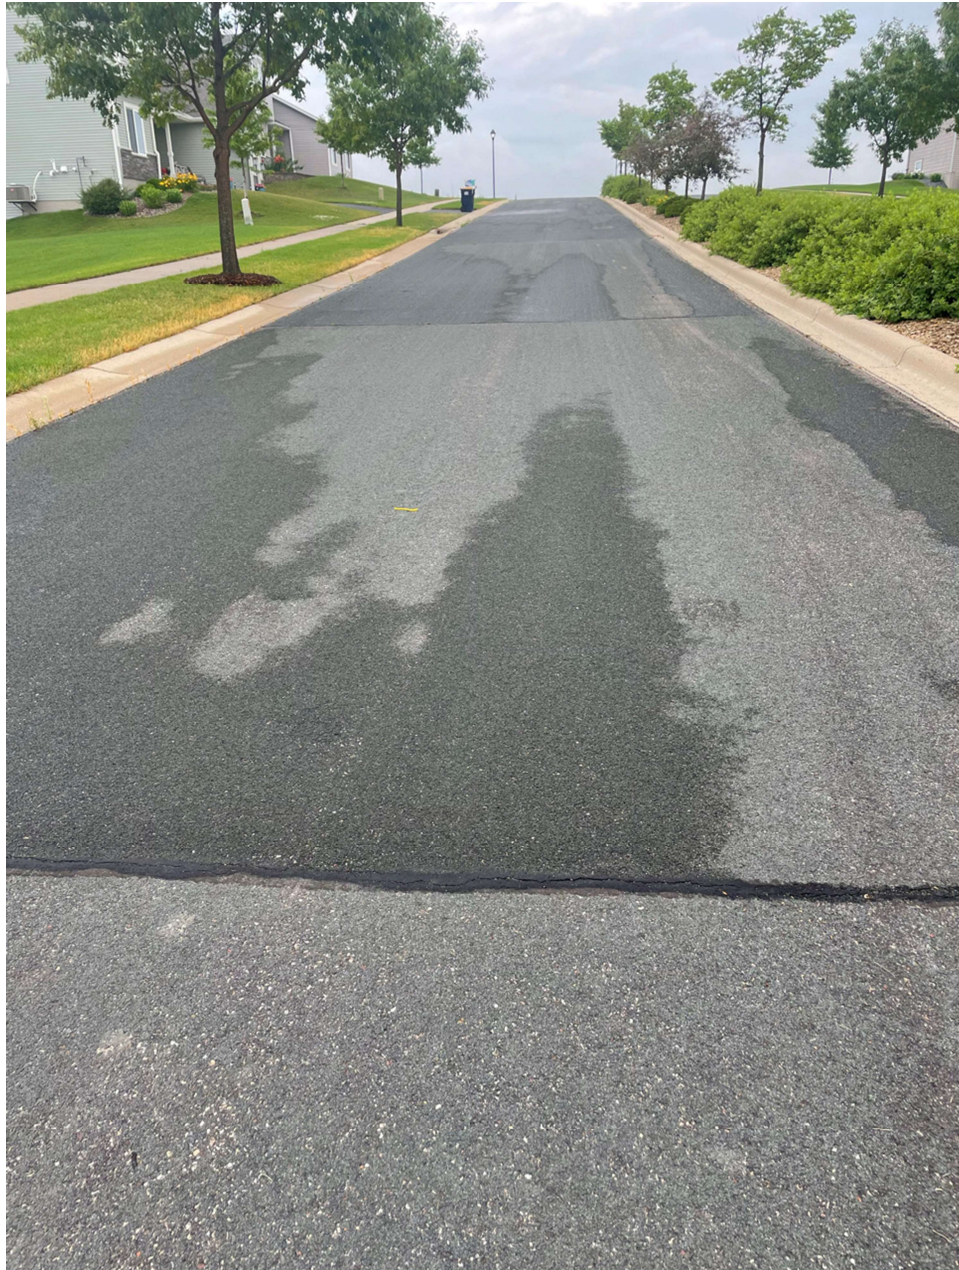
**PCI Rating = 81: Good*****Stoneridge (Segment ID: 92)***

Streets with a rating of Good have experienced enough freeze thaw cycles to show signs of distress. These distresses are usually mild with some moderate distresses also present. Drivers on these segments encounter mostly smooth rides with few bumps. While the distresses may still be relatively minor, they are prime candidates for preventative maintenance techniques. It is recommended that the City use a combination of crack sealing, chip sealing, and fog sealing to restore segments in the Good category. These strategies are relatively cheap and extremely cost-effective ways to extend the life of the pavement.

- Longitudinal/Transverse Cracking, Low Severity, 1.61%
- Longitudinal/Transverse Cracking, Moderate Severity, 0.81%
- Weathering, Moderate Severity, 100.00%

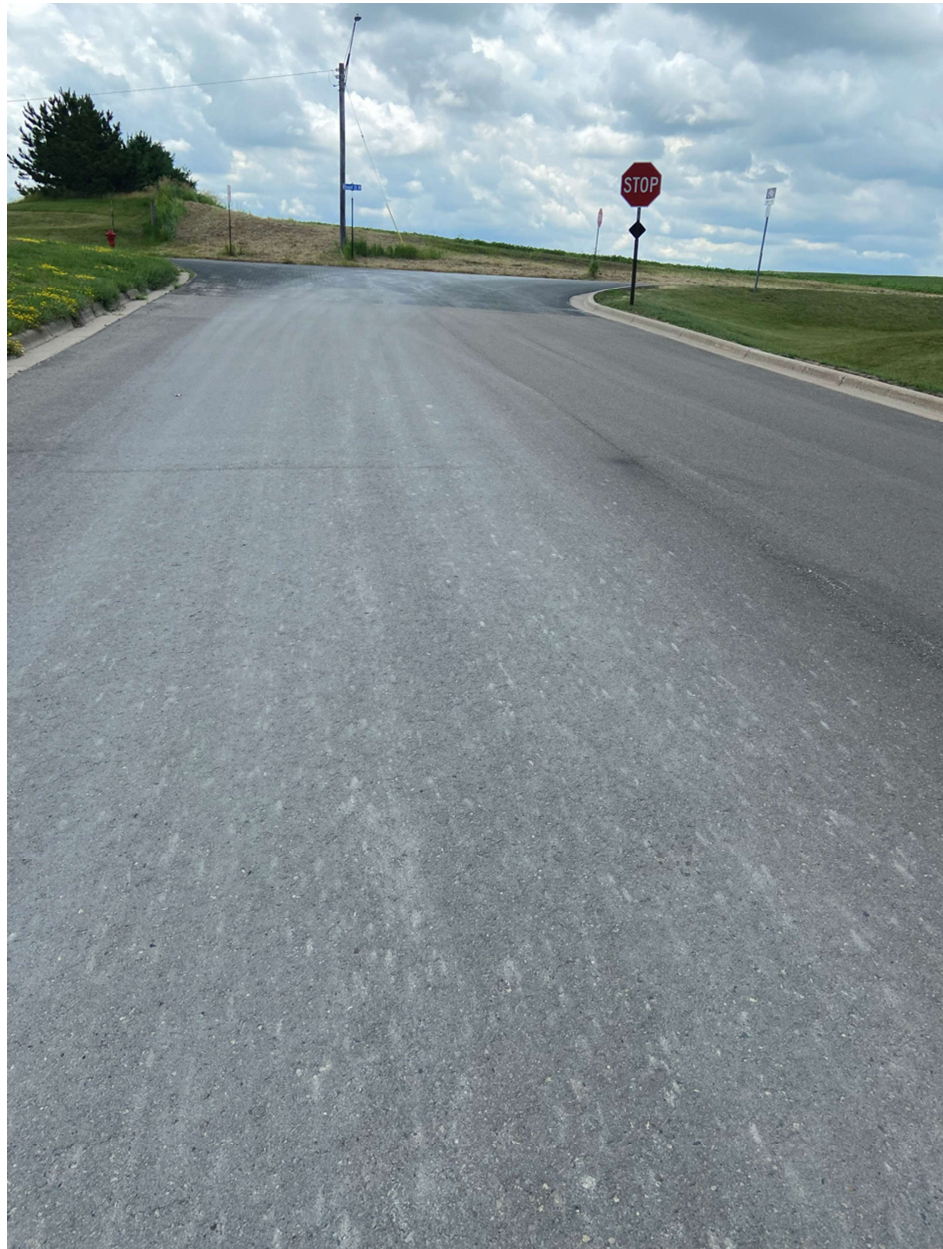
**PCI Rating = 93: Excellent*****Hester St (Segment ID: 80)***

If a pavement section is categorized as Excellent, it will have been recently resurfaced or constructed. Distresses can be present but they are usually mild in severity. Drivers will experience few if any bumps while traveling the segment. In most cases no maintenance is required on Excellent pavement. However, the City should be proactive by crack sealing seams and any early cracks to prevent seepage into the base of the road.

- Longitudinal/Transverse Cracking, Low Severity, 1.12%
- Weathering, Low Severity, 100.00%

| Branch ID | Section ID | Length (ft) | Area (ft <sup>2</sup> ) | 2022 PCI | Recommended Maintenance |
|---|---|---|---|---|---|
| HESTER ST | 80 | 242 | 6,783 | 93 | Corrective Maintenance |
